**Flood Control Project Maintenance  
Levee Inspections**  
**LMA District Cover Sheet**  
**Spring 2018 Levee Inspection Results**

**Reclamation District No. 1001 Nicolaus**

**Spring 2018 Levee Inspection Results**

| Waterway | | | Bank | Unit Miles |
|--|---|---|---|---|
| Unit No. 01 Yankee Slough | | | Right | 4.12 |

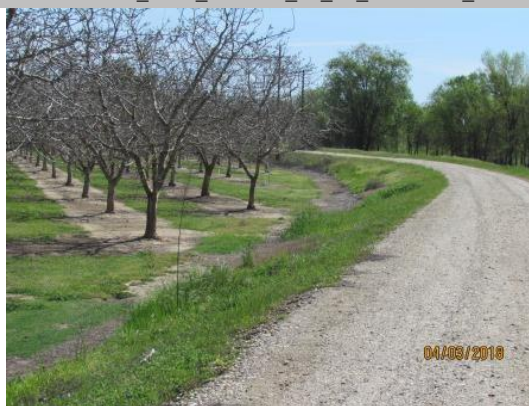
Photo 1 of 2 : SP\_2018\_RD1001\_36\_11\_20180411\_00022.jpg

| Annual vegetation is well maintained, Spring 2018. | | | | | |

View looking upstream landside of the well maintained annual vegetation, Spring 2018.

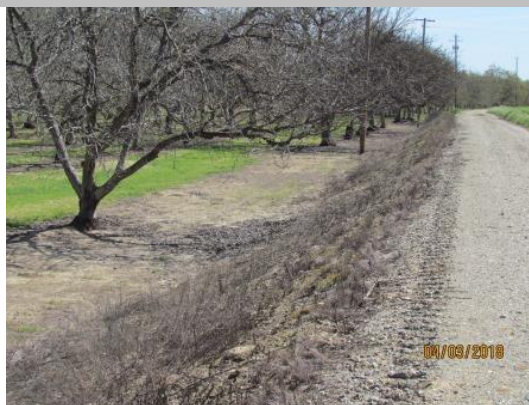
Photo 2 of 2 : SP\_2018\_RD1001\_36\_11\_20180411\_00021.jpg

Second view looking upstream landside of the well maintained annual vegetation, Spring 2018.

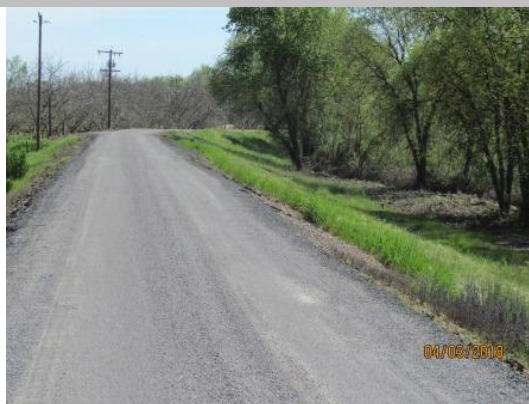
Photo 1 of 1 : SP\_2018\_RD1001\_36\_12\_20180411\_00024.jpg

| Annual vegetation is well maintained, Spring 2018. | | | | | |

View looking upstream waterside of the well maintained annual vegetation, Spring 2018.

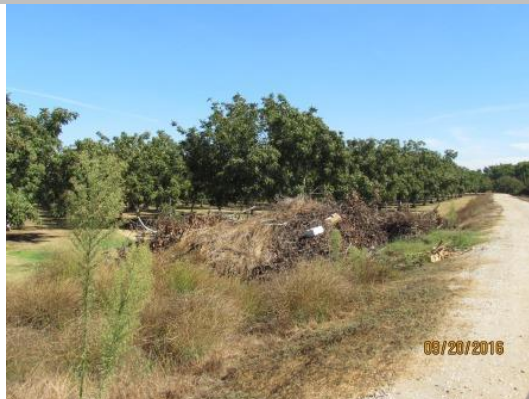
Photo 1 of 1 : SP\_2018\_RD1001\_36\_26\_20180302\_00017.jpg

View of pruning's on landside toe looking upstream. Fall 2016.

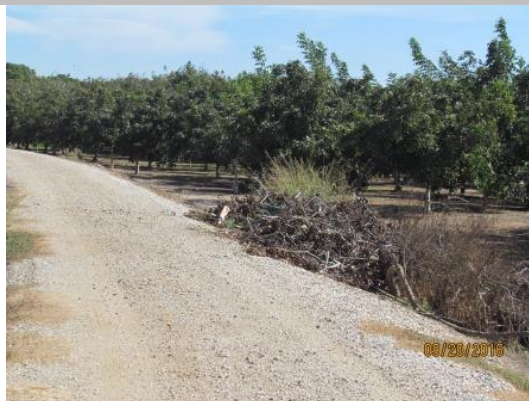
Photo 1 of 1 : SP\_2018\_RD1001\_36\_9\_20180302\_00006.jpg

View of pruning's on waterside slope looking upstream. Fall 2016.

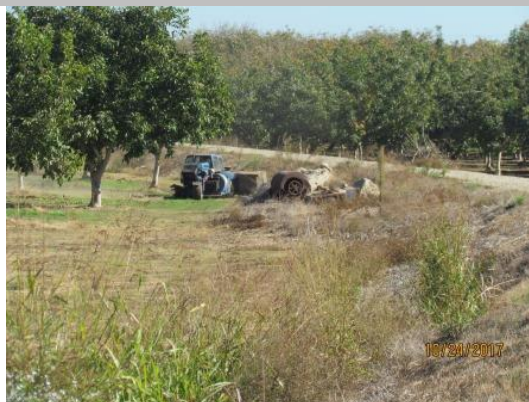
Photo 1 of 1 : SP\_2018\_RD1001\_36\_16\_20180302\_00011.jpg

View looking upstream at concrete debris on landside slope, Fall 2017.

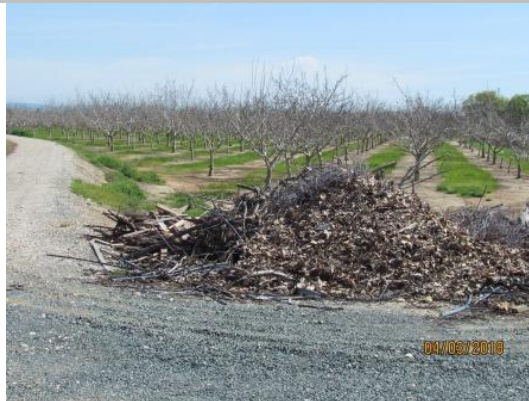
Photo 1 of 1 : SP\_2018\_RD1001\_36\_17\_20180411\_00030.jpg

This photo was taken of the landside at pruning's and debris stacked up at the levee toe. Spring 2018.

| Remove pruning's and debris off levee toe, Spring 2018. | | | | | |

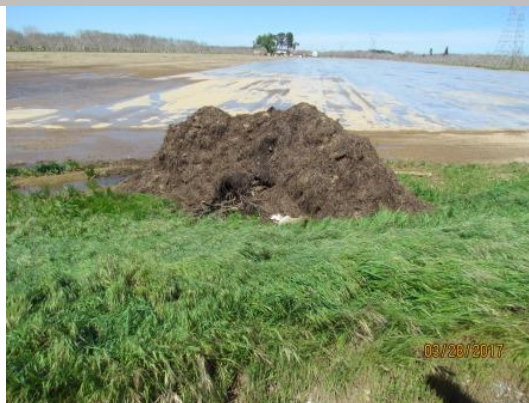
Photo 1 of 1 : SP\_2018\_RD1001\_36\_27\_20180302\_00018.jpg

| Debris/pruning's at landside levee toe, Fall 2017. | | | | | |

View of debris/pruning's at landside levee toe, Spring 2017.

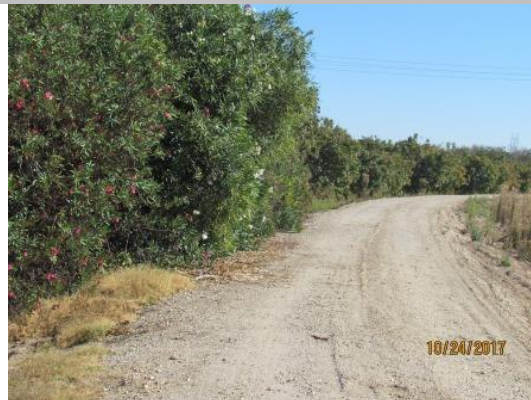
Photo 1 of 1 : SP\_2018\_RD1001\_36\_15\_20180302\_00010.jpg

View of the landscaping on the landside levee slope, Fall 2017.

| Landscaping needs to be removed from levee toe, Fall 2017. | | | | | | | | | | |

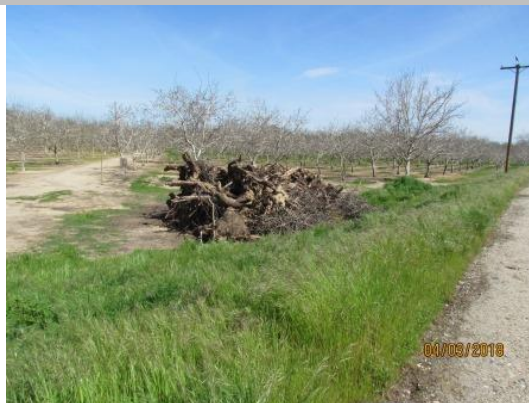
Photo 1 of 1 : SP\_2018\_RD1001\_36\_7\_20180411\_00029.jpg

This photo was taken of the landside looking upstream at prunings stacked up at the levee toe. Spring 2018.

| Pruning's need to be removed off the levee toe, Spring 2018. | | | | | |

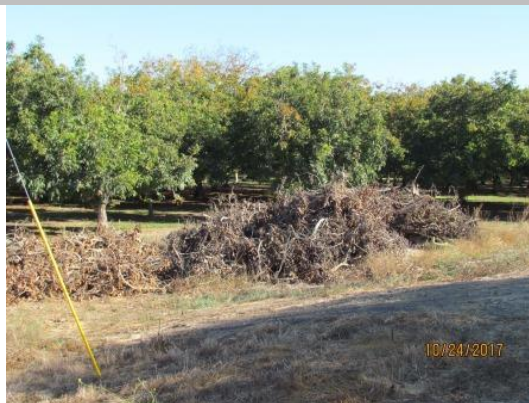
Photo 1 of 1 : SP\_2018\_RD1001\_36\_22\_20180302\_00016.jpg

View of pruning's on the landside toe looking upstream. Fall 2017.

| Prunings need to be removed, Fall 2017. | | | | | |

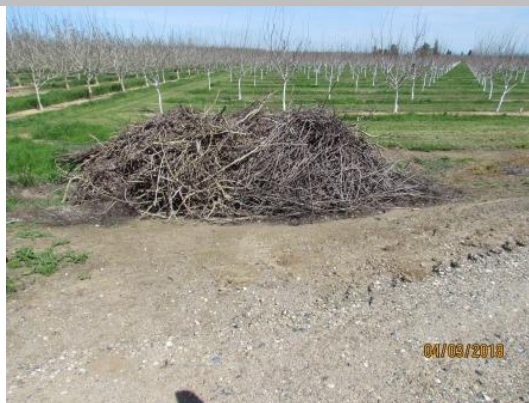
Photo 1 of 1 : SP\_2018\_RD1001\_36\_6\_20180411\_00028.jpg

This photo was taken of the landside looking upstream at prunings stacked up at the levee toe. Spring 2018.

| Pruning's still at levee toe need to be removed, Spring 2018. | | | | | |

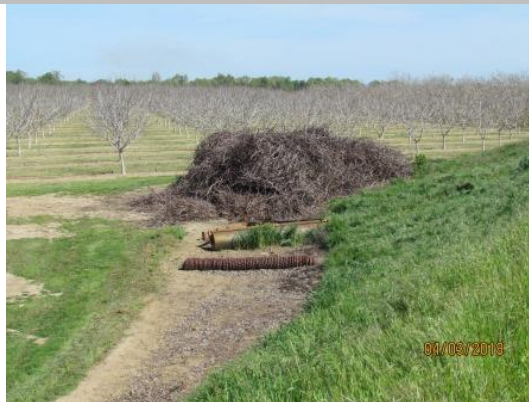
Photo 1 of 1 : SP\_2018\_RD1001\_36\_14\_20180411\_00027.jpg

View looking upstream landside of pruning's that have been places at levee toe, Spring 2018.

| Remove pruning's from levee toe, Spring 2018. | | | | | |

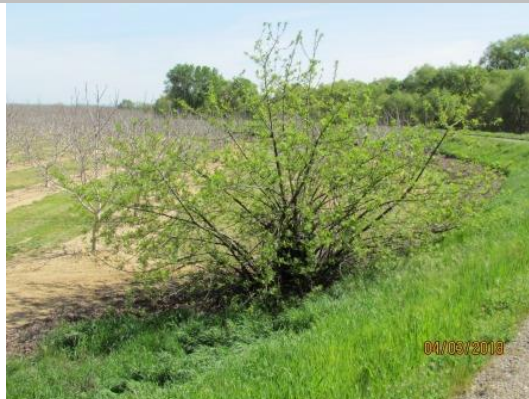
Photo 1 of 2 : SP\_2018\_RD1001\_36\_19\_20180411\_00026.jpg

View of a tree that need limbs trimmed, Spring 2018.

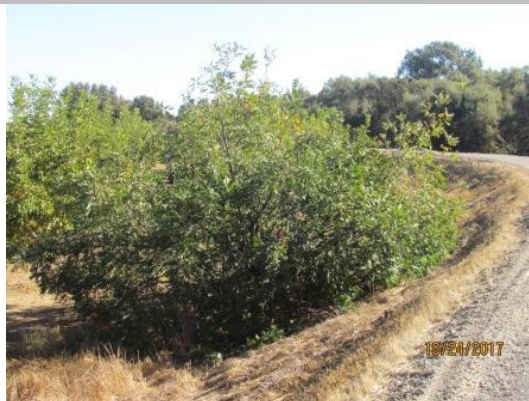
Photo 2 of 2 : SP\_2018\_RD1001\_36\_19\_20180302\_00014.jpg

View of a tree that need limbs trimmed. Fall 2017.

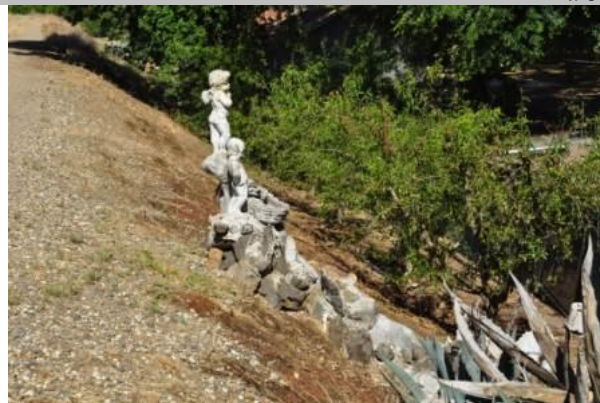
Photo 1 of 2 : SP\_2018\_RD1001\_36\_5\_20180302\_00002.jpg

Unit 1 Landscaping on levee slope. L/S

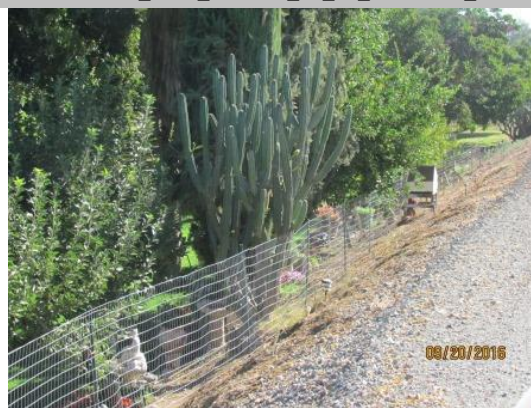
Photo 1 of 1 : SP\_2018\_RD1001\_36\_20\_20180302\_00015.jpg

| Land owner has installed an unpermitted fence on the landside levee slope. | | | | | |

View of a fence on the landside levee slope looking upstream. Fall 2016.

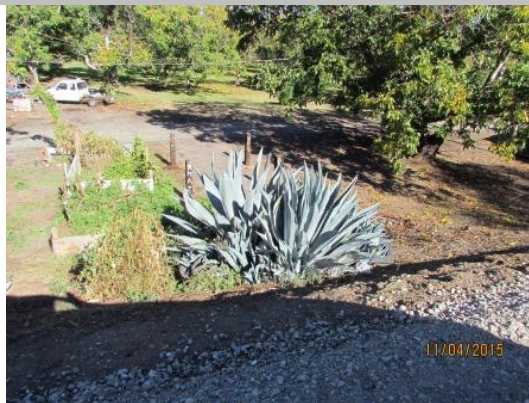
Photo 1 of 1 : SP\_2018\_RD1001\_36\_4\_20180302\_00001.jpg

View of the landscaping at the landside levee toe.

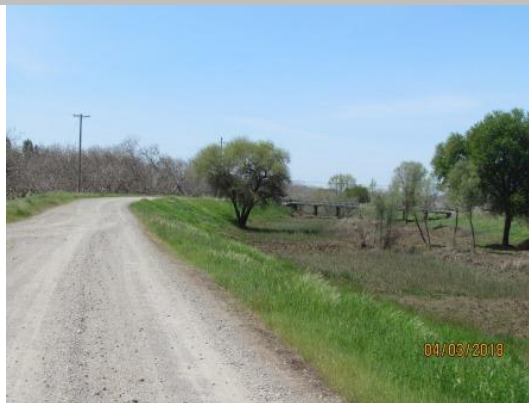
Photo 1 of 1 : SP\_2018\_RD1001\_35\_9\_20180411\_00028.jpg

| Annual vegetation is well maintained, Spring 2018. | | | | | |

View looking downstream waterside of the well maintained annual vegetation, Spring 2018.

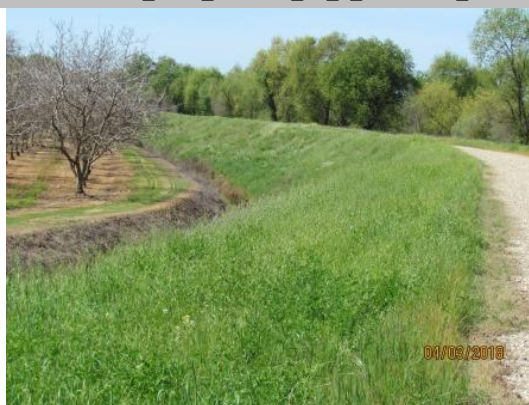
Photo 1 of 1 : SP\_2018\_RD1001\_35\_7\_20180411\_00029.jpg

| Annual vegetation has gotten to tall for visual inspection of slope, Spring 2018. | | | | | |

View looking downstream landside of the annual vegetation that needs to be maintained for better visual inspection, Spring 2018.

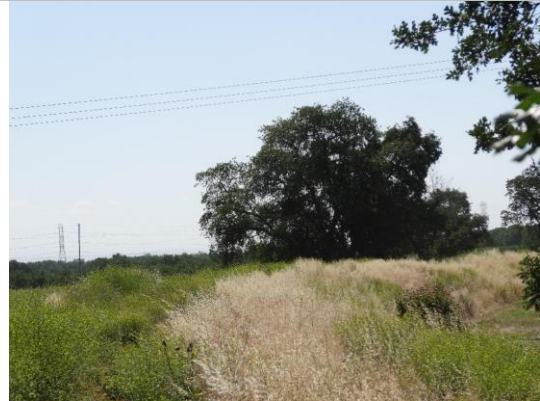
Levee Crown: dense vegetation on levee crown and sides.

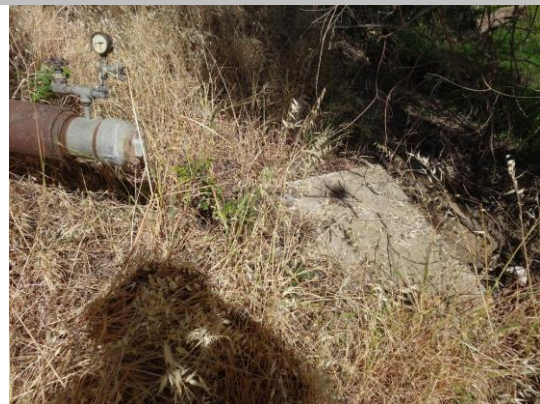
WS- plugged pipe and pump base.

| FS_ID:41673<br>DS_ID:22536<br>EP_NO: 5562<br>Repair Type: Non-Urgent<br>Crossing Status: Found<br>UCIP Comments: Pipe appears abandoned and if so should be done so properly. WS pipe plugged with stopper. Seems abandoned. Only abandoned pump base found.<br>FIELD_STRUCT_DESC: 6-inch coated steel irrigation pipe through the levee, 3.5 feet below the crown. Metal cutoff collar placed on the pipe at the center of the levee crown. Pump was removed. Pump base on the waterside (WS) berm. Shutoff valve on the discharge side of the pump. Foot valve below water on the intake side of the pump. Siphon breaker on the landside (LS) shoulder. Pipe discharges into underground irrigation system on the LS. Power pole and meter box, 10 feet from the landward toe. 1.5-inch flexible conduit through levee, 3.5 feet below the crown. (Pump and irrigation pipe authorized under Permit No. 5562, 1966 - Samuel B. Single). [Additional Reference(s): DWR Levee Log, 1993].<br>FS Date: 5/23/2013 | | | | | | |

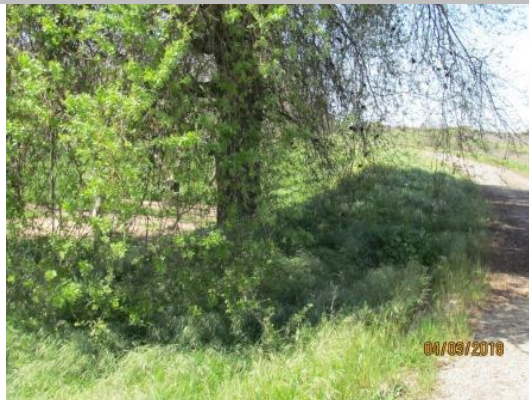
Photo 1 of 1 : SP\_2018\_RD1001\_35\_14\_20180411\_00030.jpg

View looking downstream landside of tree that needs its limbs trimmed for access and visibility, Spring 2018.

| Tree needs its limbs trimmed for access and visibility, Spring 2018. | | | | | |

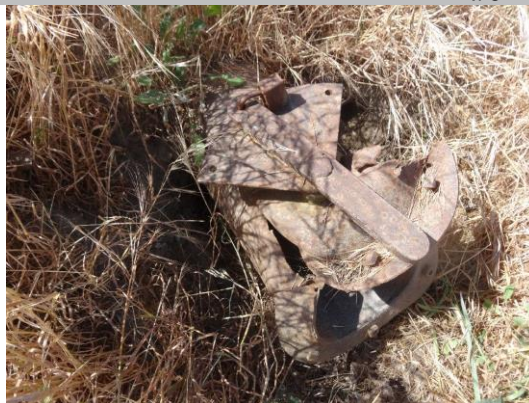
Photo 1 of 3 : UCIP\_SP\_2018\_50740\_22753.jpg

FS\_ID:50740  
DS\_ID:22529  
EP\_NO: 2281  
Repair Type: Non-Urgent  
Crossing Status: Not Found  
UCIP Comments: 07/13/2016 According to district president Joe Henderson, pipe was removed 2-3 years ago. No permit for removal found or evidence of pipe or its removal found. (K. Fazel - UCIP)05/23/2013:- leaky pipe end and erosion on WS.- cracked dirt mound on LS - seems not been used for some time. (P. Amatya - DWR)  
FIELD\_STRUCT\_DESC: \*REMOVED\* 7-inch steel irrigation pipe through the levee, 1.9 feet below the crown. Portable pump mounted on the bank during the summer months. Control valve on the waterside (WS). Steel plate bolted on the WS end during the winter months. Pipe discharges into a 30-inch concrete standpipe at the landside (LS) toe. (Pump and irrigation pipe authorized under Permit No. 2281, 1956 - Willard R. Brown). [Additional Reference(s): DWR Levee Log, 1993].  
FS Date: 7/13/2016

WS- end of the pipe.

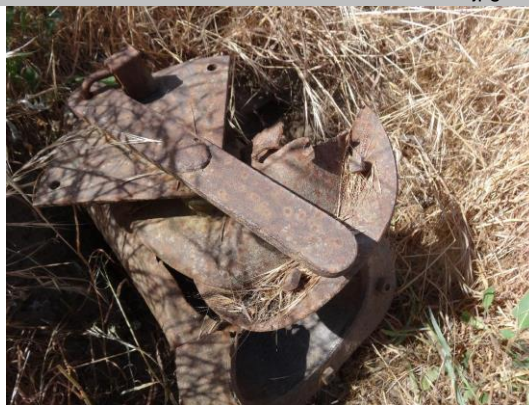
Photo 2 of 3 : UCIP\_SP\_2018\_50740\_22752.jpg

WS- seems abandoned or not been used for some time.

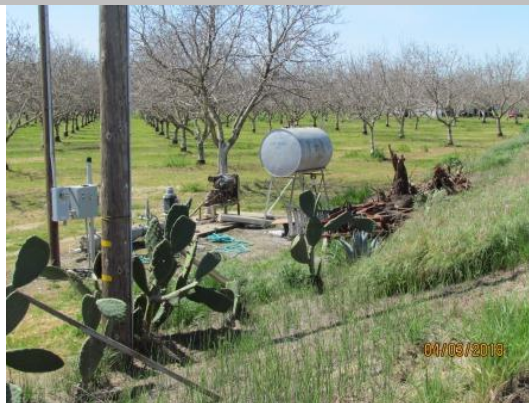
Photo 1 of 2 : SP\_2018\_RD1001\_35\_21\_20180411\_00031.jpg

View looking downstream landside, equipment has been moved but fuel tank remains, Spring 2018.

| Tank at landside levee toe need to be removed from easement, Spring 2018. | | | | | |

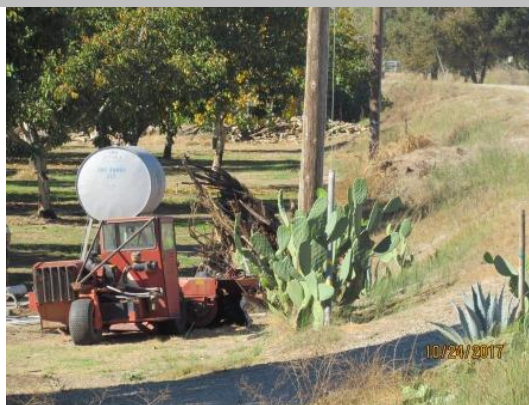
Photo 2 of 2 : SP\_2018\_RD1001\_35\_21\_20180302\_00013.jpg

View of an backhoe and tank at landside levee toe looking downstream. Fall 2017.

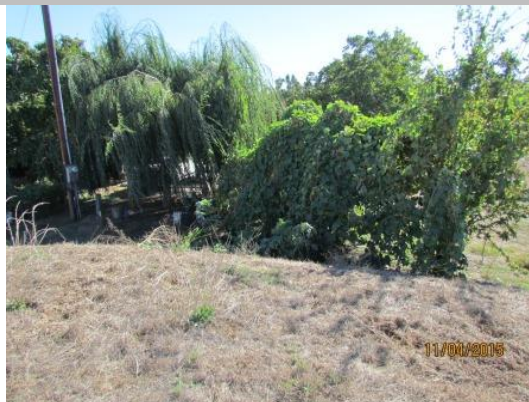
Photo 1 of 1 : SP\_2018\_RD1001\_35\_16\_20180302\_00010.jpg

View of the landscaping at the landside levee toe.

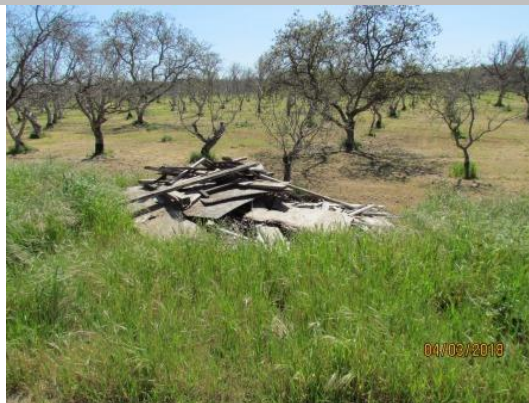
Photo 1 of 1 : SP\_2018\_RD1001\_35\_22\_20180411\_00032.jpg

| Debris has been piled up again, Spring 2018. | | | | | |

View of debris pile on the landside levee slope looking downstream, Spring 2018.

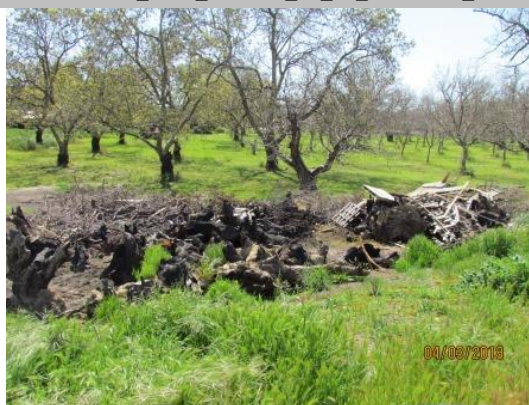
Photo 1 of 1 : SP\_2018\_RD1001\_35\_29\_20180411\_00033.jpg

View looking downstream landside at pruning's and stumps that need to be removed from levee toe, Spring 2018.

| Stumps and debris need to be removed, Fall 2017. | | | | | |

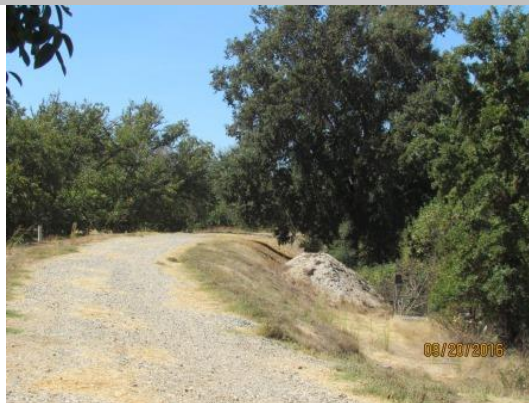
Photo 1 of 1 : SP\_2018\_RD1001\_35\_12\_20180302\_00008.jpg

View of a pile of soil on the waterside slope looking downstream. Fall 2016.

| Sand pile needs to be remove from waterside slope, Fall 2017. | | | | | |

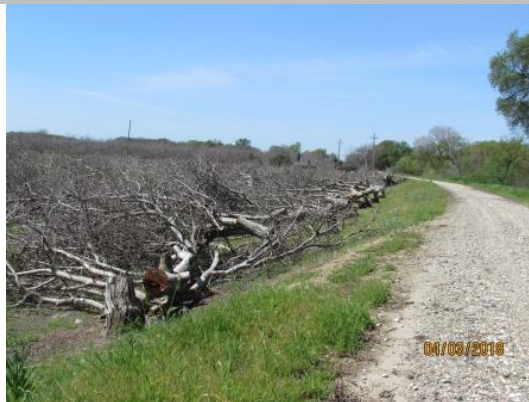
Photo 1 of 1 : SP\_2018\_RD1001\_35\_15\_20180411\_00035.jpg

View looking downstream of removed orchard trees that have been placed at toe of levee, Spring 2018.

| Remove orchard trees that have been cut down, Spring 2018. | | | | | |

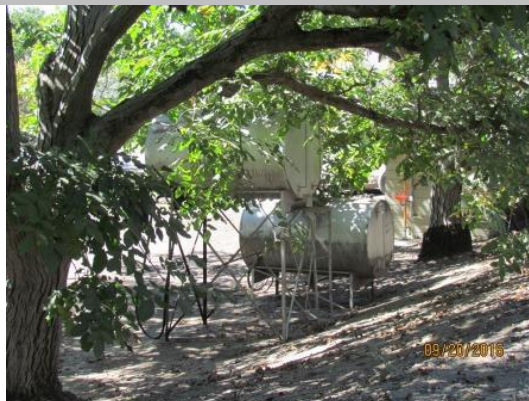
Photo 1 of 1 : SP\_2018\_RD1001\_35\_23\_20180302\_00015.jpg

| Two tanks that are at the landside levee toe and should be moved from the easement. | | | | | |

View of two tanks that are at the landside levee toe. Fall 2016.

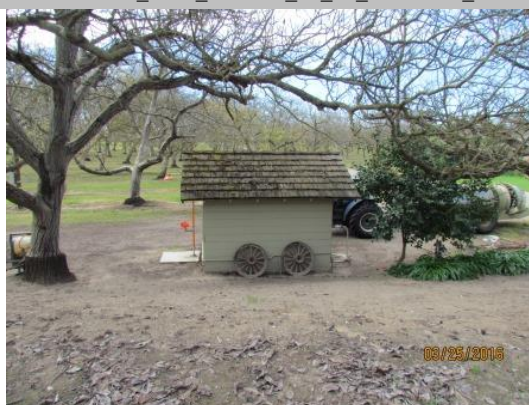
Photo 1 of 1 : SP\_2018\_RD1001\_35\_18\_20180302\_00011.jpg

Shed at landside toe.

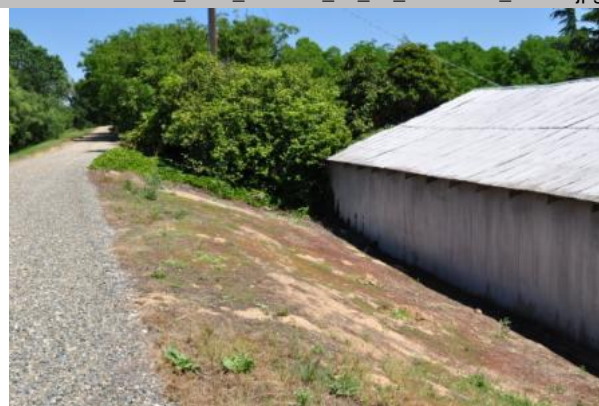
Photo 1 of 1 : SP\_2018\_RD1001\_35\_11\_20180302\_00007.jpg

RD 1001 Unit 2 - L/S -Building @ toe.

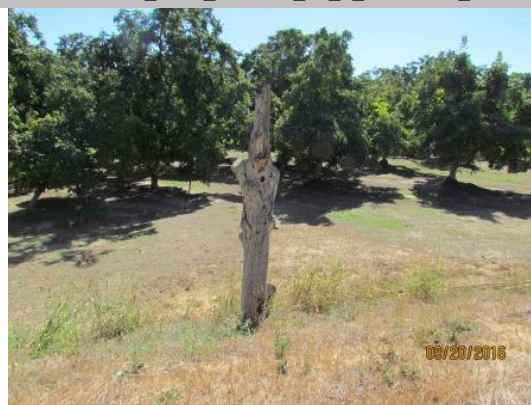
Photo 1 of 1 : SP\_2018\_RD1001\_35\_6\_20180302\_00002.jpg

View of large stump at the landside levee toe. Fall 2016.

| Large stump at the landside levee toe should be removed, Fall 2017. | | | | | |

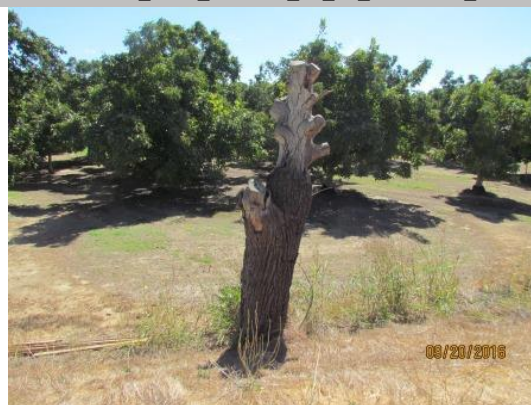
Photo 1 of 1 : SP\_2018\_RD1001\_35\_13\_20180302\_00009.jpg

View of large stump at the landside levee toe. Fall 2016.

| Large stump at the landside levee toe should be removed, Fall 2017. | | | | | |

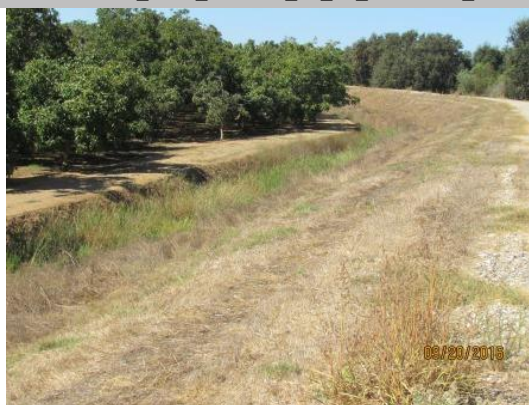
Photo 1 of 1 : SP\_2018\_RD1001\_35\_52\_20180302\_00018.jpg

View of landside irrigation ditch looking downstream. Fall 2016.

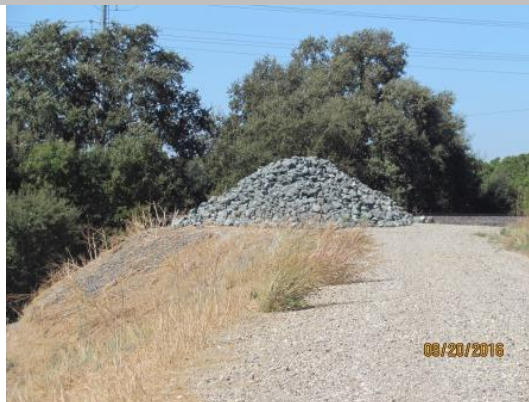
Photo 1 of 1 : SP\_2018\_RD1001\_35\_24\_20180302\_00016.jpg

| Stockpiled flood fight material. Fall 2016. | | | | | |

View of stockpiled flood fight material. Fall 2016.

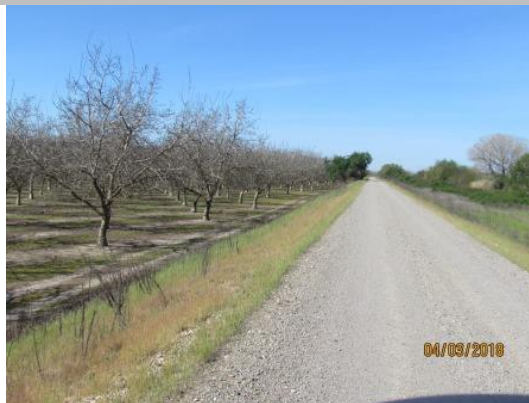
Photo 1 of 1 : SP\_2018\_RD1001\_37\_13\_20180409\_00054.jpg

| Annual vegetation is well maintained, Spring 2018. | | | | | |

View looking downstream landside of the well maintained annual vegetation, Spring 2018.

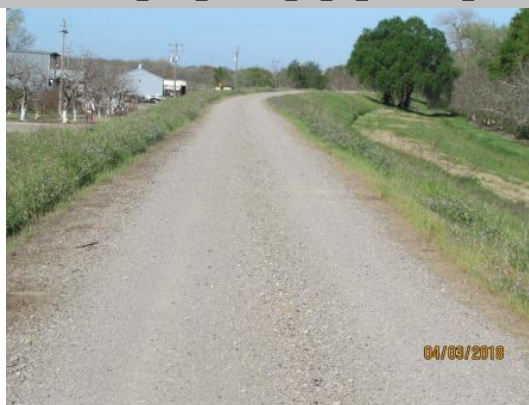
Photo 1 of 1 : SP\_2018\_RD1001\_37\_15\_20180409\_00052.jpg

| Annual vegetation is well maintained, Spring 2018. | | | | | |

View looking downstream waterside of the well maintained annual vegetation, Spring 2018.

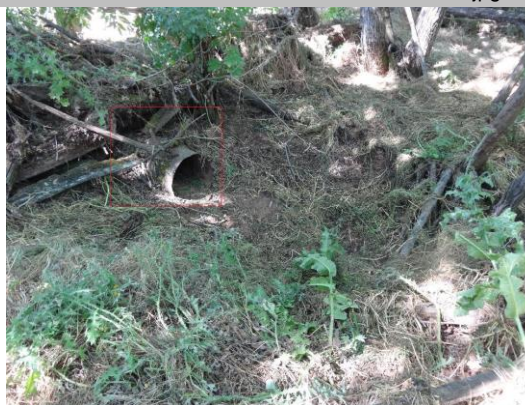
Photo 1 of 3 : UCIP\_SP\_2018\_14128\_23308.jpg

| FS_ID:14128<br>DS_ID:22549<br>EP_NO: 958<br>Repair Type: Non-Urgent<br>Crossing Status: Found<br>UCIP Comments: - slide gate on WS not found- needs abandoned properly.<br>FIELD_STRUCT_DESC: *ABANDONED* 24-inch irrigation pipe of an unknown material through the levee, at an unknown depth. Slide gate on the waterside (WS) end. (24-inch irrigation pipe authorized under Permit No. 958, 1944 - Frank B. Lichty and Maggie Lichty).<br>FS Date: 5/21/2013 | | | | | |

WS- abandoned CMP on berm of the levee.

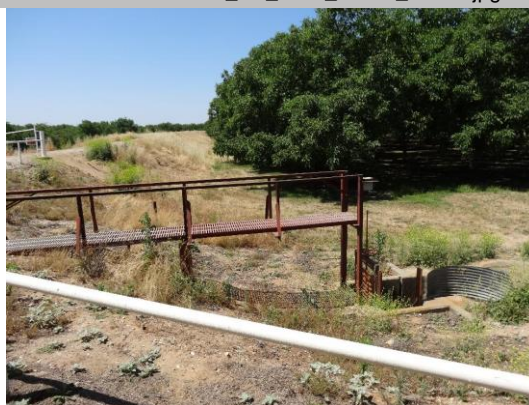
Photo 1 of 3 : UCIP\_SP\_2018\_41727\_23325.jpg

| FS_ID:41727<br>DS_ID:22561<br>EP_NO: 4505<br>Repair Type: Non-Urgent<br>Crossing Status: Found<br>UCIP Comments: Two small steel pipes sleeved through 30-inch CMP may be a compliance issue as slidegate cannot close.- this may have been converted into drainage pipe (?) - big CMP standpipe on WS.<br>FIELD_STRUCT_DESC: 30-inch concrete encased corrugated metal irrigation pipe through the levee, 11 feet below the crown. Concrete headwall and slide gate at the waterside (WS) toe, removed. Metal walkway on the WS to the slide gate. Pipe discharges into a 48-inch concrete standpipe at the landside (LS) toe. Two vertical pumps. (30-inch concrete encased corrugated metal irrigation pipe authorized under Permit No. 4505, 1964 - State of California, Department of Public Works, Division of Highways). [Additional Reference(s): DWR Levee Log, 1993. USACE Sacramento O&M Manual 141.1, August 1955, (Station 949+00), 30-inch steel pipe referenced].<br>FS Date: 5/21/2013 | | | | | |

WS- steel walkway, CMP and concrete headwall

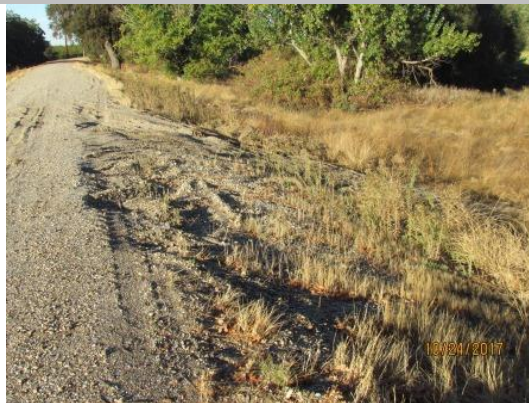
Photo 2 of 2 : SP\_2018\_RD1001\_37\_30\_20180302\_00024.jpg

| Damage to landside slope by vehicles needs to be repaired, Spring 2018. | | | | | |

View looking downstream waterside where slope has been disturbed by vehicle traffic, Fall 2017.

| S3 : Repair the levee slope damaged by vehicle traffic and prevent access where possible. | | | | | |

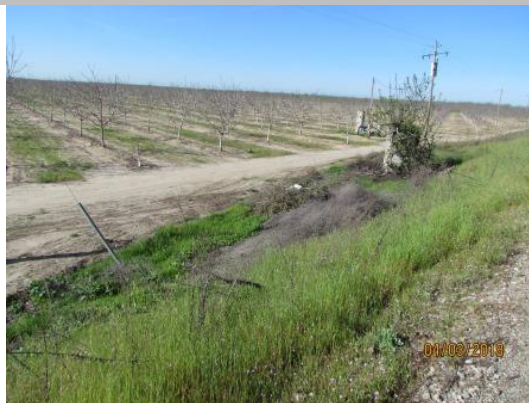
Photo 1 of 1 : SP\_2018\_RD1001\_37\_16\_20180409\_00060.jpg

| Pruning's at levee toe need to be removed. Spring 2017. | | | | | |

View of pruning's at levee toe landside that need to be removed, Spring 2018.

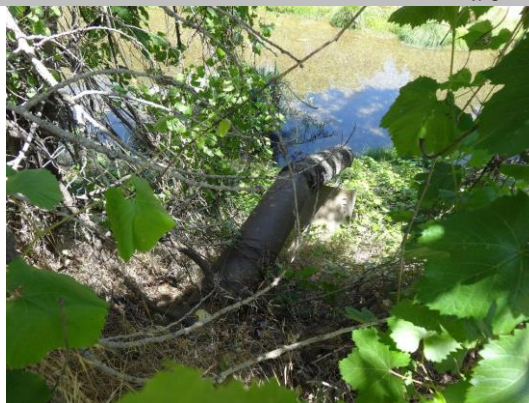
Photo 1 of 2 : UCIP\_SP\_2018\_41722\_23338.jpg

| FS_ID:41722<br>DS_ID:22562<br>EP_NO: N/A<br>Repair Type: Non-Urgent<br>Crossing Status: Found<br>UCIP Comments: Verify pipe has been abandoned properly.- pump mounted on the riverbank not found, - butterfly valve in a 30-inch concrete riser at the waterward toe not found,- concrete box on landside not found- a big tree inside concrete standpipe on landside found.<br>FIELD_STRUCT_DESC: *ABANDONED* 22-inch steel pipe through the levee, 18.3 feet below the crown. Pump mounted on the riverbank. Butterfly valve in a 30-inch concrete riser at the waterside (WS) toe. Pipe discharges into a concrete box and concrete standpipe on the landside (LS). Steel plate bolted to the WS end of the pipe during the winter months. (California Packing Corporation). [Additional Reference(s): DWR Levee Log, 1993].<br>FS Date: 5/21/2013 | | | | | |

WS- only a steel pipe found on riverbank.

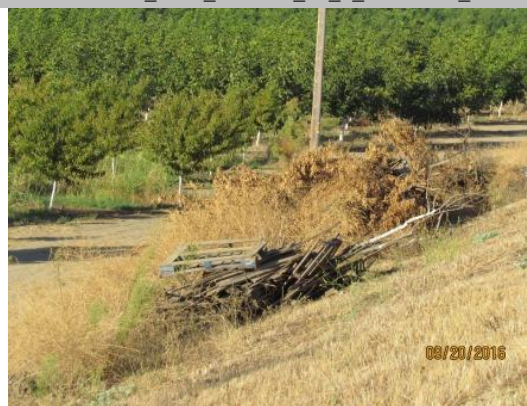
Photo 1 of 1 : SP\_2018\_RD1001\_37\_5\_20180302\_00006.jpg

View of the prunings at the landside levee toe. Fall 2016.

| Remove trimmings and debris from levee slope, Fall 2017. | | | | | |

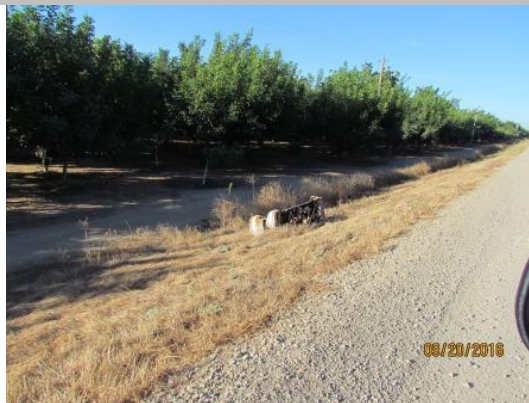
Photo 1 of 1 : SP\_2018\_RD1001\_37\_42\_20180302\_00036.jpg

View of a couch on the landside levee slope looking downstream. Fall 2016.

| Remove couch on levee slope, Spring 2018. | | | | | |

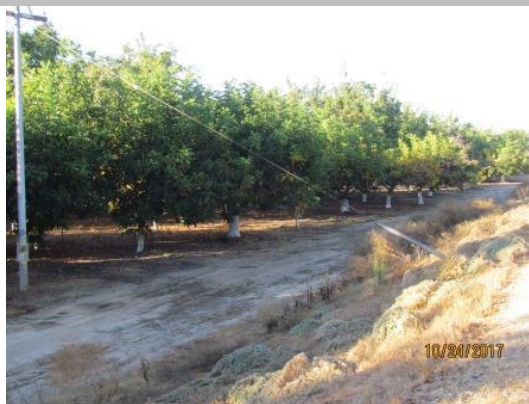
Photo 1 of 1 : SP\_2018\_RD1001\_37\_54\_20180302\_00040.jpg

| Guy wire in levee slope near crown. | | | | | |

View looking downstream landside of a guywire into the levee slope, Fall 2017.

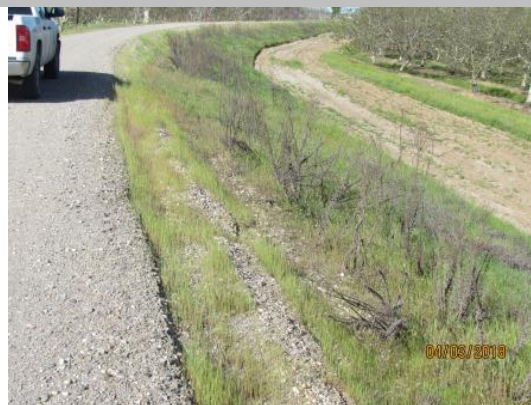
Photo 1 of 2 : SP\_2018\_RD1001\_37\_21\_20180409\_00063.jpg

Erosion on waterside slope still remains as of Spring 2018.

| E2 : Schedule repair of erosion site prior to the next inspection. | | | | | |

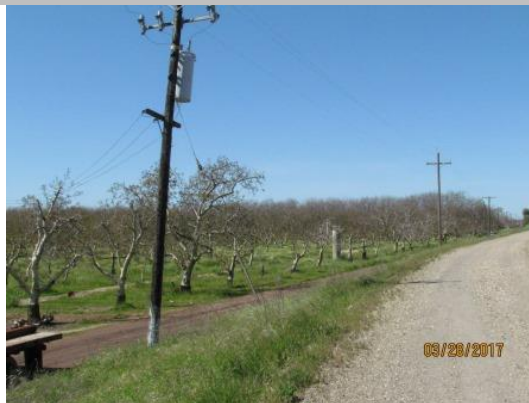
Photo 1 of 1 : SP\_2018\_RD1001\_37\_20\_20180302\_00018.jpg

| Unpermitted pole line. | | | | | |

View looking downstream of unpermitted pole, Spring 2017.

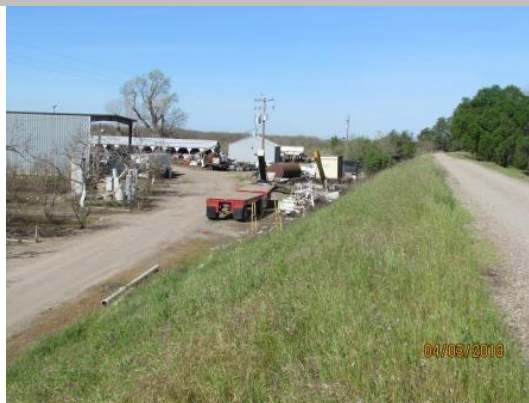
Photo 1 of 2 : SP\_2018\_RD1001\_37\_7\_20180409\_00064.jpg

| Land owner continues to leave debris and equipment next to levee toe, Spring 2018. | | | | | |

Irrigation pipe equipment and plastic cans within the easement of the levee. Spring 2018.

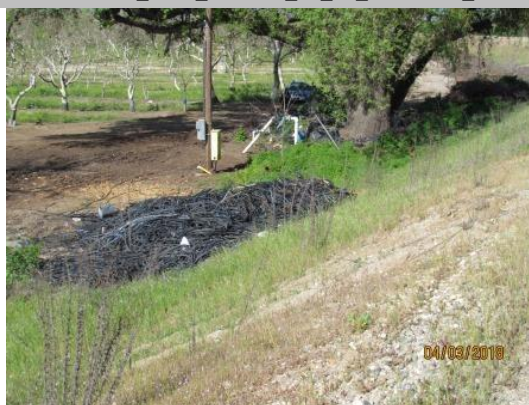
Photo 1 of 2 : SP\_2018\_RD1001\_37\_26\_20180409\_00066.jpg

View of the same drip irrigation and trash on levee slope. Spring 2018.

| Remove drip irrigation and trash from levee slope. Spring 2018. | | | | | |

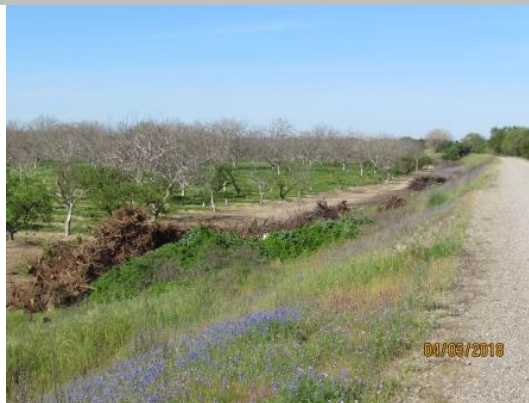
Photo 1 of 2 : SP\_2018\_RD1001\_37\_33\_20180409\_00067.jpg

View looking downstream landside of the same pruning's on levee slope from Fall 2017 to Spring 2018.

| Remove prunings at levee toe. Spring 2018. | | | | | |

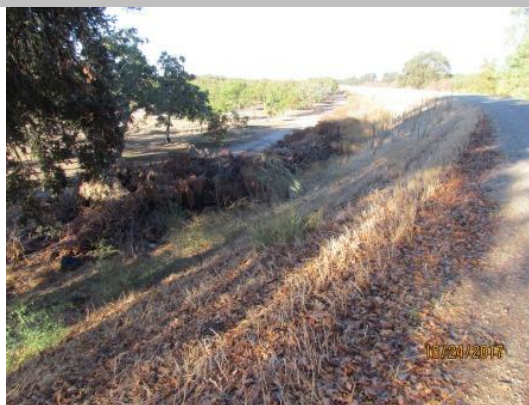
Photo 2 of 2 : SP\_2018\_RD1001\_37\_33\_20180302\_00027.jpg

View looking downstream landside of pruning's on levee slope, Fall 2017.

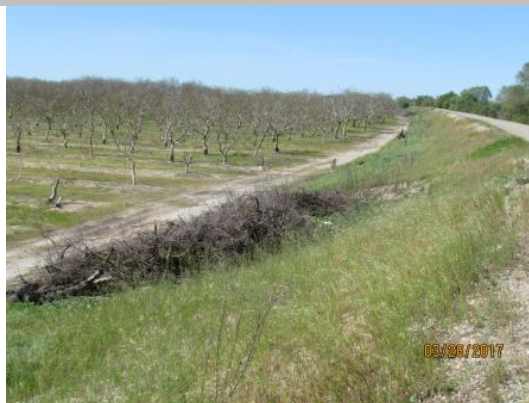
Photo 1 of 2 : SP\_2018\_RD1001\_37\_9\_20180302\_00010.jpg

| Pruning's still on levee toe, Fall 2017. | | | | | |

There is a still a pile of pruning's at the toe. Spring 2017.

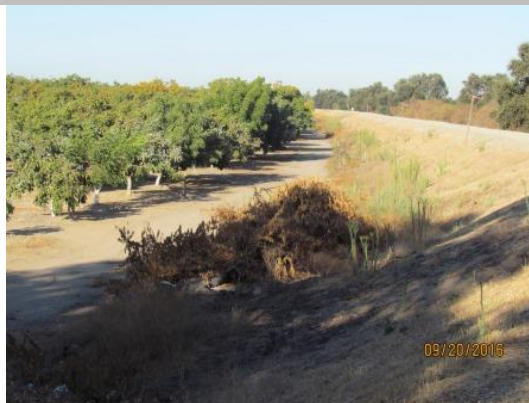
Photo 2 of 2 : SP\_2018\_RD1001\_37\_9\_20180302\_00009.jpg

| Pruning's still on levee toe, Fall 2017. | | | | | | |

Drip irrigation tubing has been removed that was within the easement of the landside levee. There is a new pile of pruning's at the toe. Fall 2016

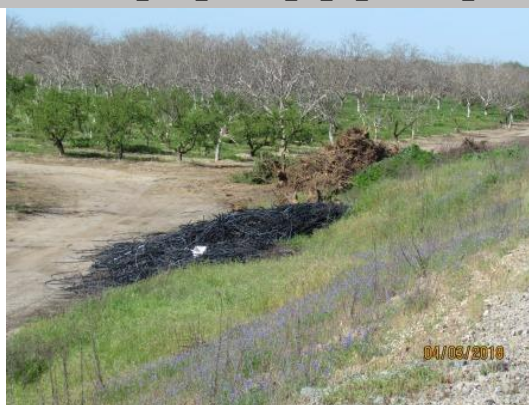
Photo 1 of 2 : SP\_2018\_RD1001\_37\_35\_20180409\_00069.jpg

View looking downstream landside of drip irrigation and trash still on levee slope. Spring 2018.

| Remove drip irrigation along levee toe. Spring 2018. | | | | | |

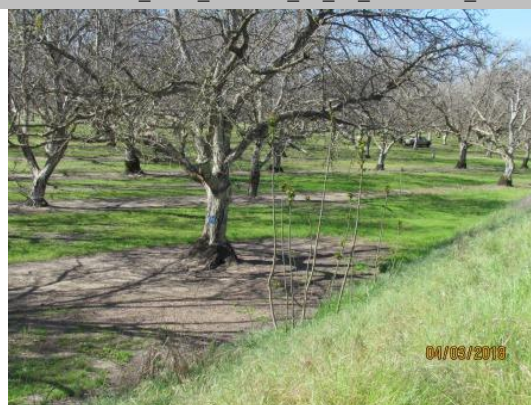
Photo 1 of 1 : SP\_2018\_RD1001\_37\_32\_20180409\_00070.jpg

View of landside were trees less than 4" in diameter should be removed, Spring 2018.

| Trees less than 4" in diameter should be removed, Spring 2018. | | | | | |

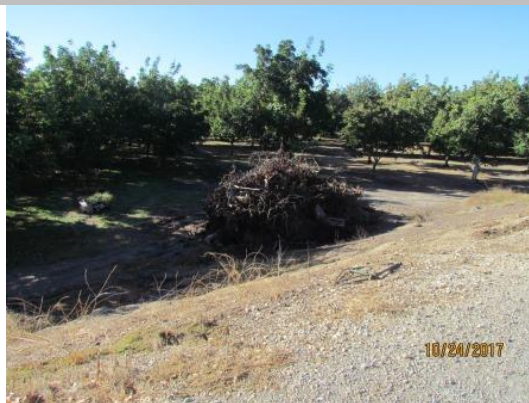
Photo 1 of 1 : SP\_2018\_RD1001\_37\_39\_20180302\_00032.jpg

View looking downstream landside of walnut stumps and pruning's within the easement of the levee, Fall 2017.

| Remove existing pruning's from levee toe, Spring 2018. | | | | | |

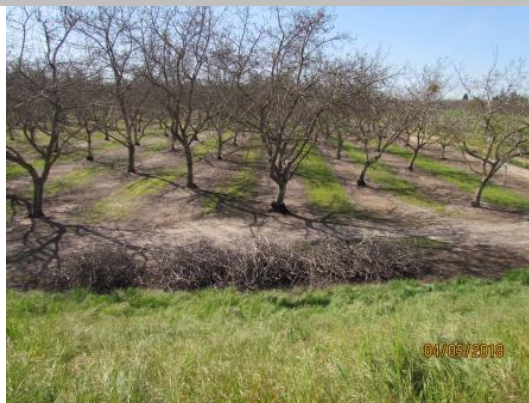
Photo 1 of 1 : SP\_2018\_RD1001\_37\_19\_20180409\_00074.jpg

View looking downstream landside of pruning's within the easement of the levee, Spring 2018.

| Remove existing pruning's from levee toe, Spring 2018. | | | | | |

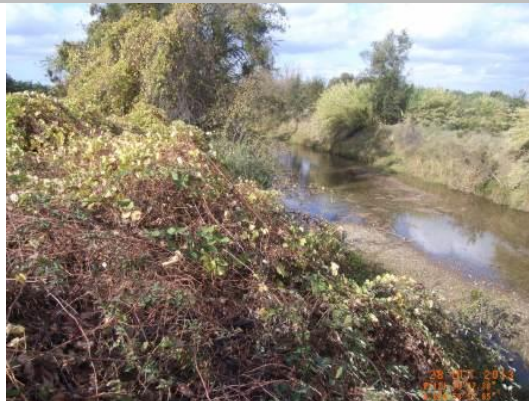
Photo 1 of 1 : SP\_2018\_RD1001\_37\_17\_20180302\_00017.jpg

| 2008 - Sandy/silty banks with rotational slab failures creating near vertical bank with pop-outs due to tree failures. Narrow berm. 2015: Last observed in 2013. [2015 Site ID: BER_5-7_L] | | | | | |

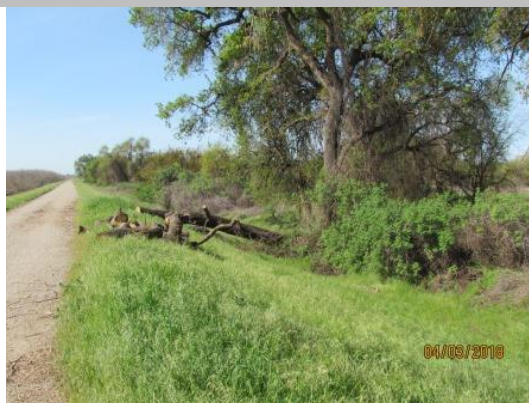
Photo 1 of 1 : SP\_2018\_RD1001\_37\_25\_20180409\_00076.jpg

View looking downstream waterside of a fallen tree that needs to be removed, Spring 2018.

| Remove fallen tree from levee slope, Spring 2018. | | | | | |

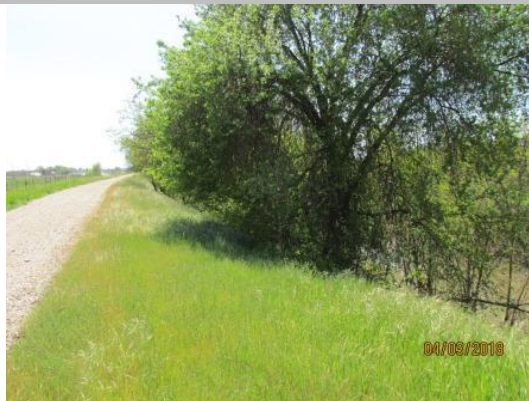
Photo 1 of 1 : SP\_2018\_RD1001\_37\_31\_20180409\_00077.jpg

View looking downstream waterside of tree that needs trimmed for access and visibility, Spring 2018.

| Trim tree limbs for access and visibility, Spring 2018. | | | | | |

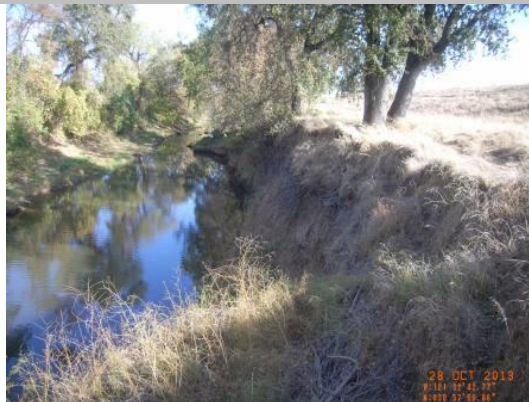
Photo 1 of 1 : SP\_2018\_RD1001\_37\_10\_20180302\_00011.jpg

| 2011 - Large section of bank has slumped off. RD has flagged and appears to be watching. 2012 - Slopes slightly steeper. 2013 - Minor new erosion observed. 2015: Last observed in 2013. [2015 Site ID: BER_2-5_L] | | | | | |

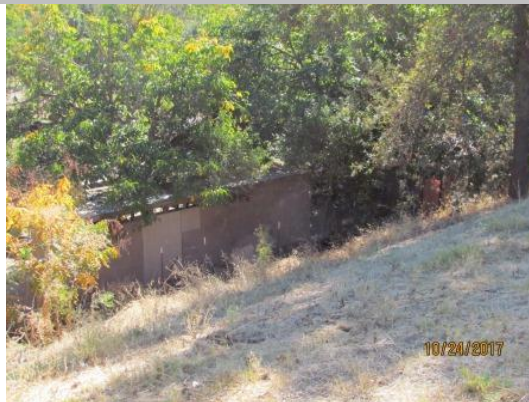
Photo 1 of 1 : SP\_2018\_RD1001\_37\_11\_20180302\_00012.jpg

| Small sheds are at levee toe, Fall 2017. | | | | | |

View of building at the landside toe. Fall 2017.

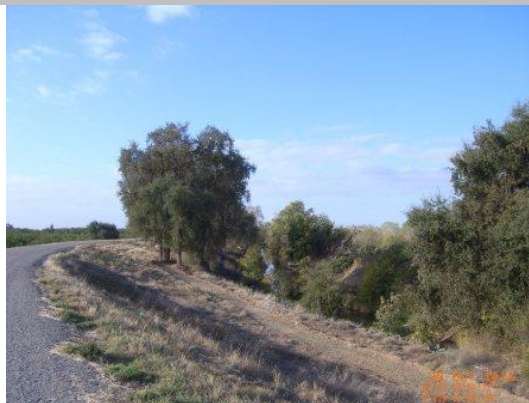
Photo 1 of 1 : SP\_2018\_RD1001\_37\_1\_20180302\_00001.jpg

| 2011 - Large slumped sections of bank. 2012 - Slopes slightly steeper. 2015: Last observed in 2013. [2015 Site ID: BER_1-9_L] | | | | | |

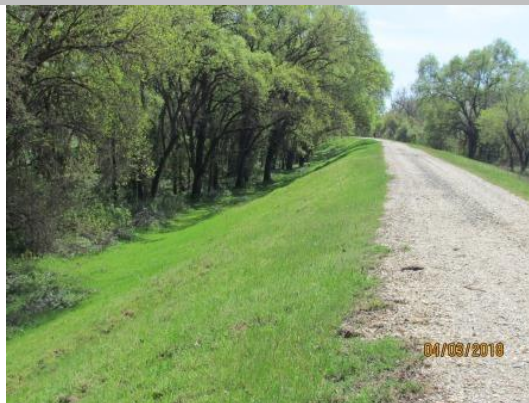
Photo 1 of 1 : SP\_2018\_RD1001\_38\_55\_20180411\_00083.jpg

| Annual vegetation is well maintained, Spring 2018. | | | | | |

View looking downstream landside of the well maintained annual vegetation, Spring 2018.

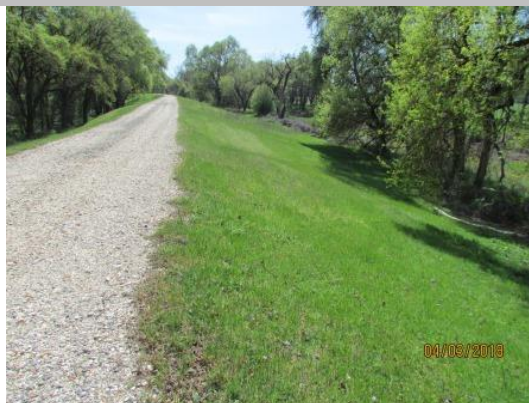
Photo 1 of 1 : SP\_2018\_RD1001\_38\_39\_20180411\_00084.jpg

| Annual vegetation is well maintained, Spring 2018. | | | | | |

View looking downstream waterside of the well maintained annual vegetation, Spring 2018.

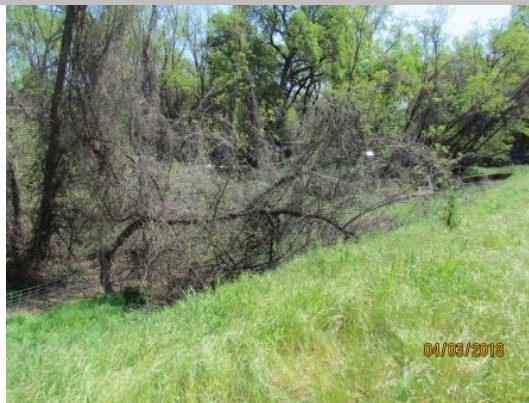
Photo 1 of 2 : SP\_2018\_RD1001\_38\_31\_20180411\_00085.jpg

View looking downstream landside of a downed tree that need to be removed from levee slope, Spring 2018.

| Remove downed tree from levee slope, Spring 2018. | | | | | |

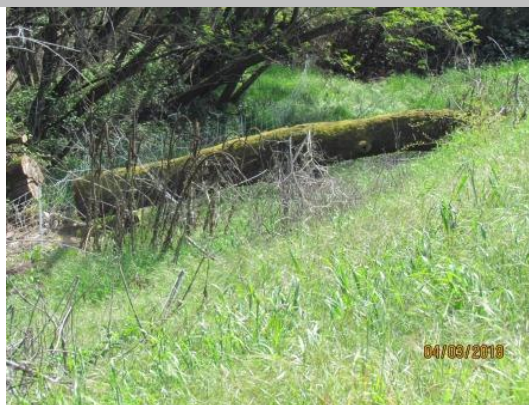
Photo 2 of 2 : SP\_2018\_RD1001\_38\_31\_20180411\_00086.jpg

Second view looking downstream landside of a downed tree that need to be removed from levee slope, Spring 2018.

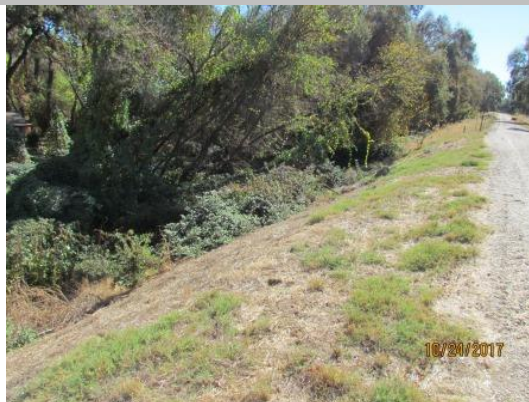
Photo 1 of 1 : SP\_2018\_RD1001\_38\_57\_20180302\_00043.jpg

View looking downstream landside of wild growth that is creeping up the levee slope, Fall 2017.

| Remove wild growth from levee slope, Fall 2017. | | | | | |

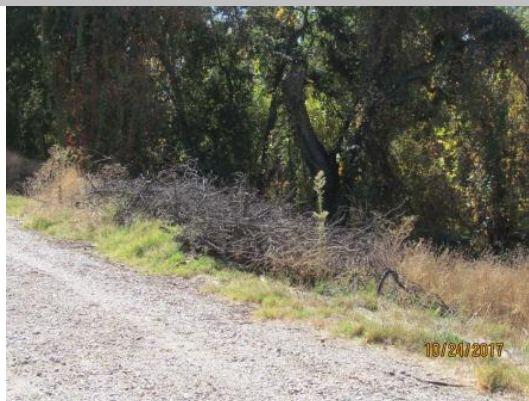
Photo 1 of 1 : SP\_2018\_RD1001\_38\_3\_20180302\_00003.jpg

View looking downstream of pruning's on hinge point, Fall 2017.

| Remove pruning's from hinge point, Fall 2017. | | | | | |

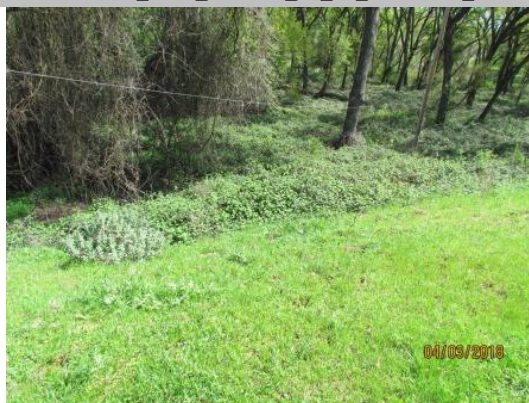
Photo 1 of 1 : SP\_2018\_RD1001\_38\_46\_20180411\_00087.jpg

View looking downstream landside of wild growth that is creeping up the levee slope, Spring 2018.

| Keep the Blackberry bush from climbing the landside levee slope, Spring 2018. | | | | | |

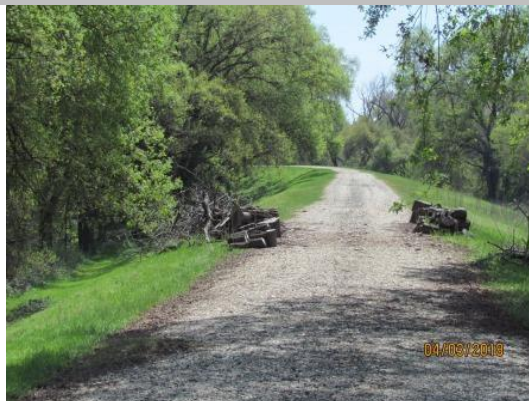
Photo 1 of 2 : SP\_2018\_RD1001\_38\_42\_20180411\_00089.jpg

View looking downstream of pruning's from fallen tree on both sides of hinge points, Spring 2018.

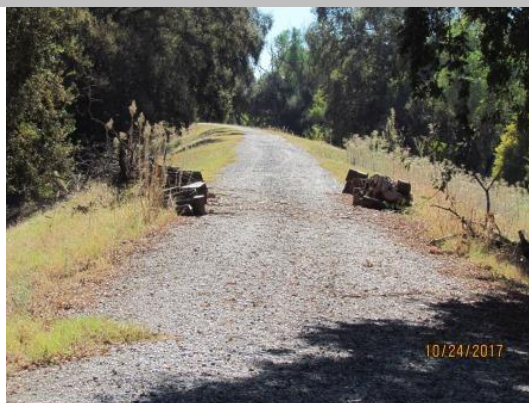
Photo 2 of 2 : SP\_2018\_RD1001\_38\_42\_20180302\_00029.jpg

View looking downstream of pruning's from fallen tree on both sides of hinge points, Fall 2017.

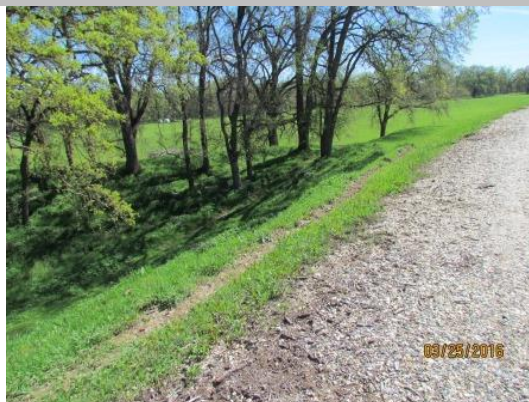
Photo 1 of 3 : SP\_2018\_RD1001\_38\_64\_20180302\_00049.jpg

| Animal trail is not being used and shows no sign of erosion or sloughing. Fall 2017. | | | | | |

Livestock trail cut into landside slope. Spring 2016.

| A2 : Repair the levee slope damaged by livestock and prevent large animal access. | | | | | |

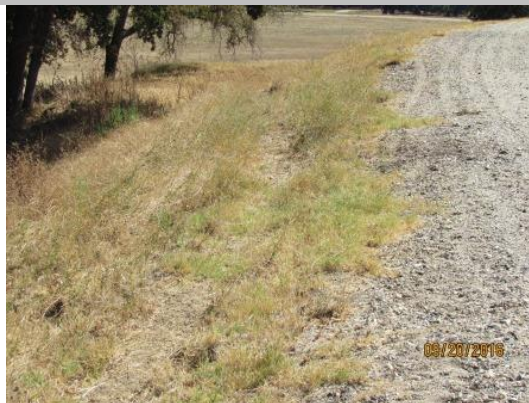
Photo 2 of 3 : SP\_2018\_RD1001\_38\_64\_20180302\_00050.jpg

View of animal trail cut into the landside levee slope. Fall 2016.

| A2 : Repair the levee slope damaged by livestock and prevent large animal access. | | | | | | |

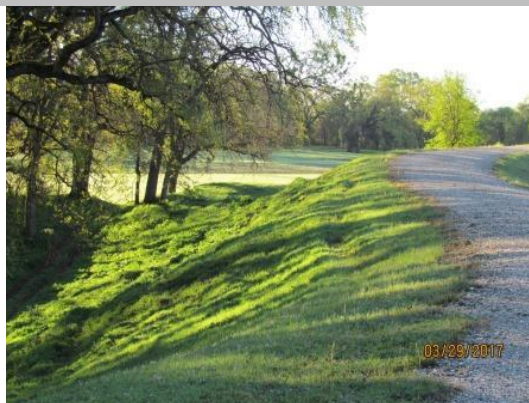
Photo 3 of 3 : SP\_2018\_RD1001\_38\_64\_20180302\_00051.jpg

View looking downstream of animal trail that is not being used and shows no sign of erosion or sloughing. Spring 2017.

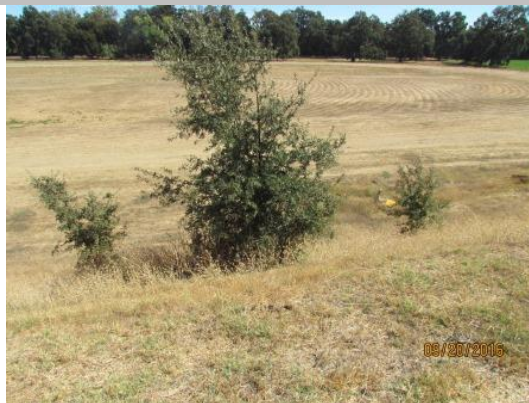
Photo 1 of 1 : SP\_2018\_RD1001\_38\_59\_20180302\_00045.jpg

View of three trees with diameters less than 4". Fall 2016.

| Trees 4" in diameter or less at chest height should be removed. | | | | | |
